Manhole Inspection Summary

Manhole # S33WW_010MH

Insp Date: **4/13/07 12:36 PM**

Location Address: **3001 LOVEGROVE ST**

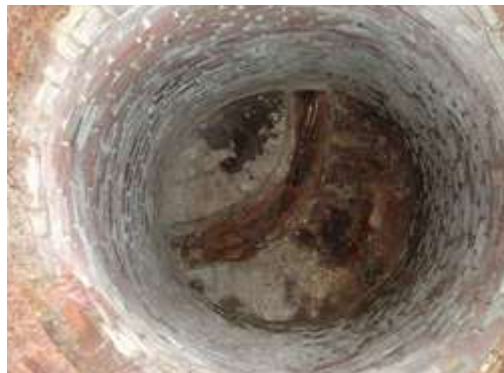
Top View

Corroded and missing steps. Barrel infiltration. Bench debris. Channel debris.

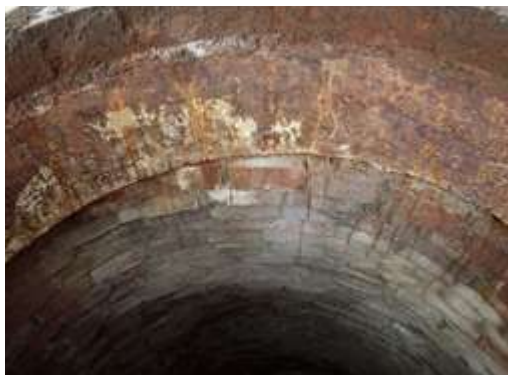
Defect

Adjustment deterioration and infiltration. Barrel infiltration - other side.

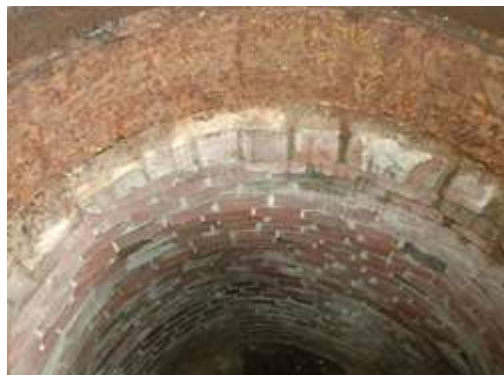
Defect

Adjustment deterioration and infiltration. Barrel infiltration.

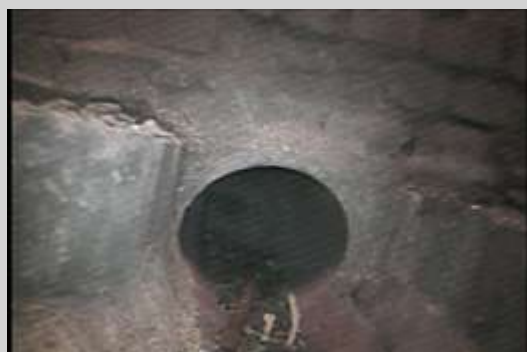
Pipe Out @ 12 O'Clock

Deposits: ☐ None ☒ **Mud** ☐ Sludge ☒ **Debris** ☐ Grease

Silt Depth: **0.5** (in.)

Deposits Extent: **Light**

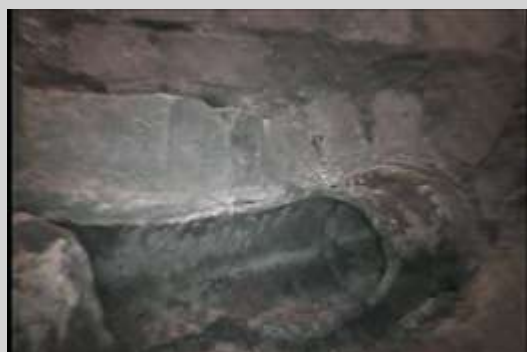
Pipe In @ 9 O'Clock

Infiltration: **Evidence**
